## 4. Structural Systems Performance

*The dominant causes of structural failure observed by the MAT included storm surge, waves, floodborne debris, and wind. Structural damage due to erosion was also common on the barrier islands. Damage occurred to residential buildings (single- and multi-family housing), commercial buildings, and critical and essential facilities.*

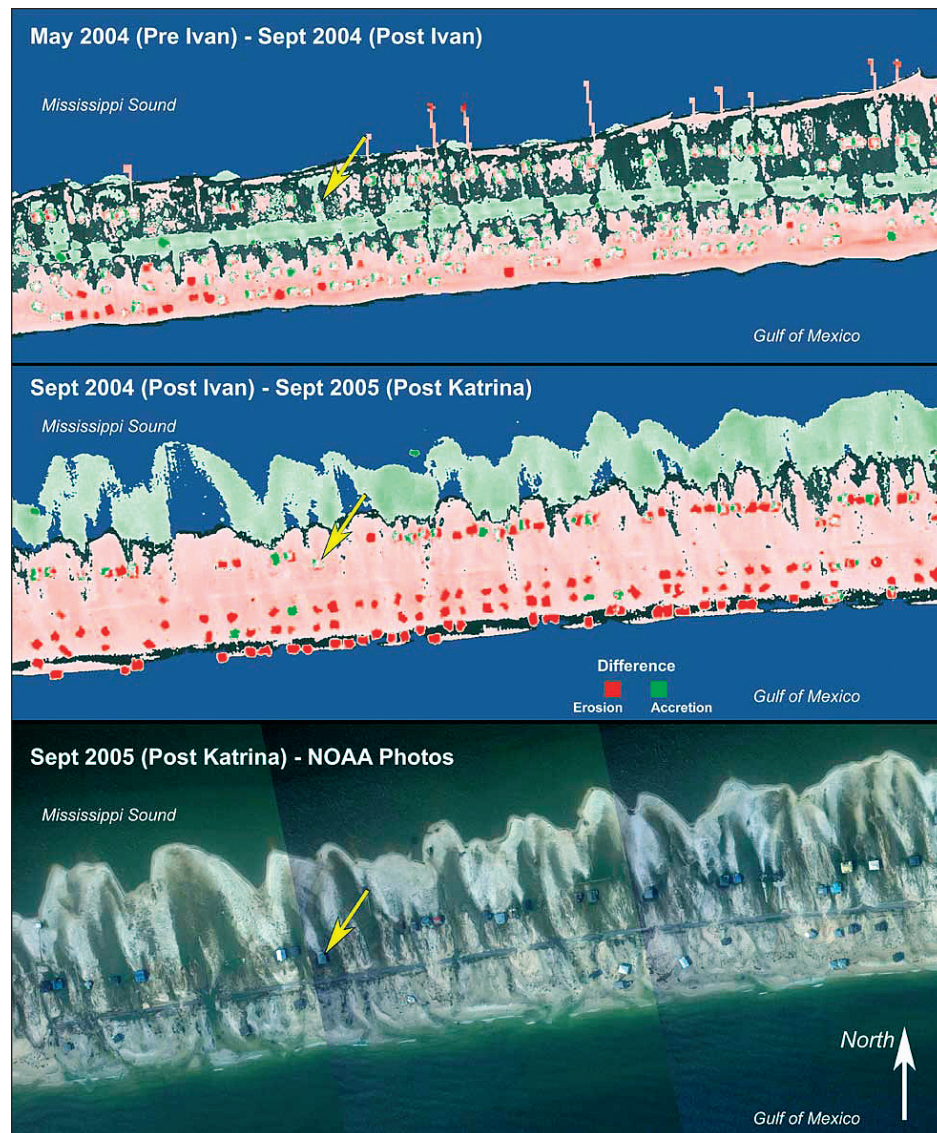
Island, Alabama, more pile-supported houses were destroyed by Katrina (108) than by Hurricane Ivan (17). Two-thirds of the 150 houses on the far west side of the island were totally destroyed and many of the remaining houses were significantly damaged. Many of these homes were not flooded to the first floor level. The failure of the pile systems was likely due to erosion and loss of foundation support from successive storms (Hurricanes Ivan, Dennis, and Katrina) that made the buildings more susceptible to pile failure.

**Figure 4-2.**  
Comparison of erosion  
patterns and building  
losses on Dauphin  
Island, Alabama, due to  
Hurricanes Ivan (2004) and  
Katrina (2005)

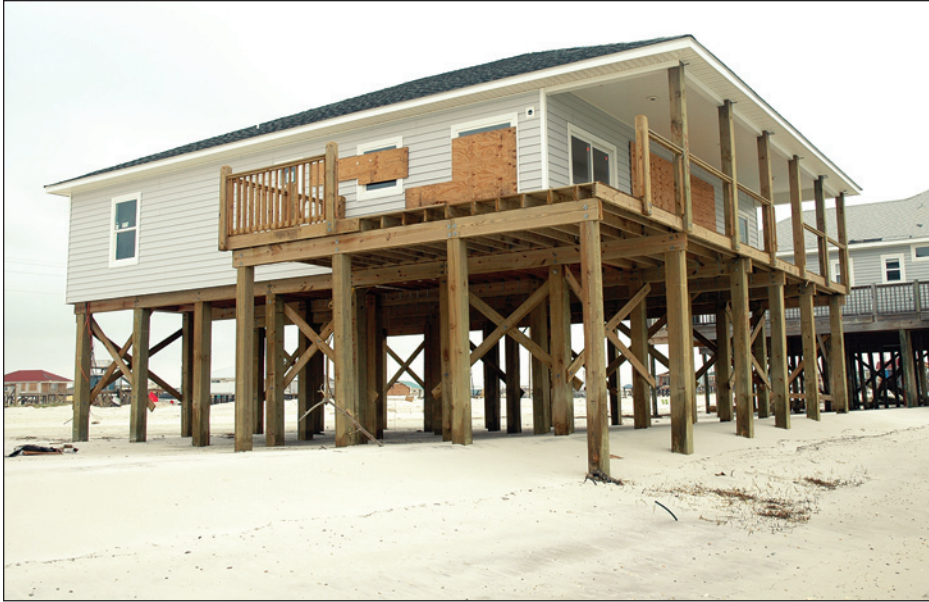
When pile foundations elevated single-family houses above the storm surge/waves and the piles were adequately embedded to tolerate the erosion, they performed well, as shown in Figures 4-3 and 4-4.

Figure 4-3.  
Successful example  
of well-elevated and  
embedded pile foundation  
following Katrina  
(Dauphin Island, Alabama)

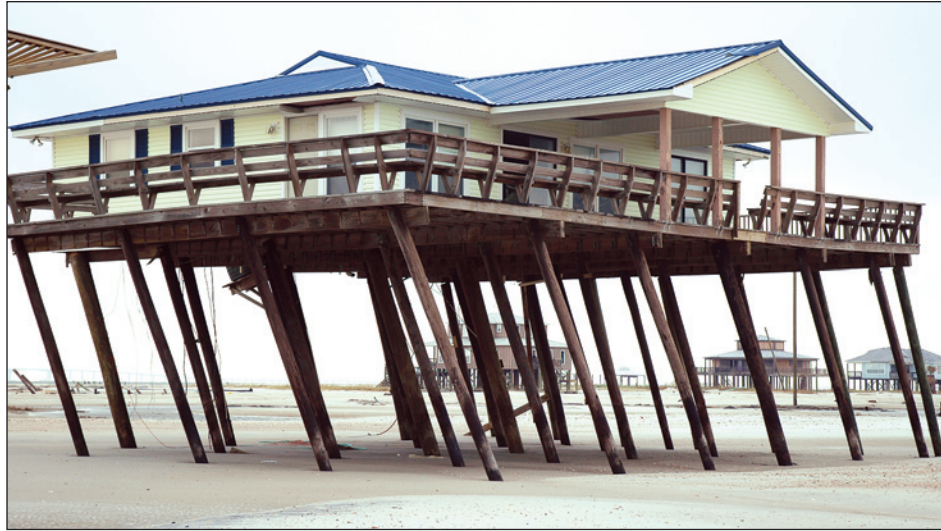
Damage and failures caused by inadequate pile embedment are shown in Figures 4-5 and 4-6. Wave damage to elevated buildings is shown in Figures 4-7 and 4-8. Once the storm surge and wave heights rose above the bottom of the floor beams and joists, either on stable foundations or when the foundation was undermined, the buildings were quickly destroyed by the waves, leaving little debris on the island.

Figure 4-6.  
Leaning piles indicate  
building failures due  
to shallow embedment  
(Dauphin Island,  
Alabama).

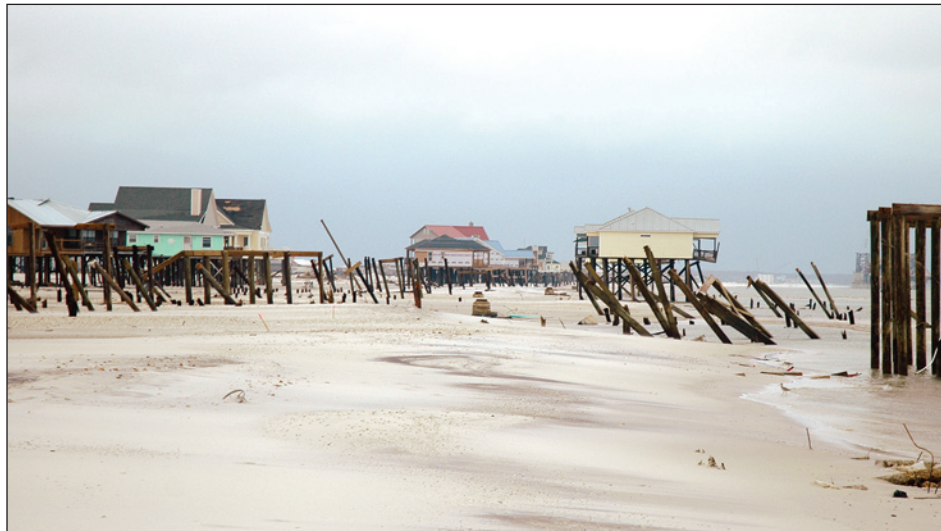
Figure 4-7.  
Partial wave damage  
after wave heights  
exceeded the floor  
elevations (Dauphin  
Island, Alabama)

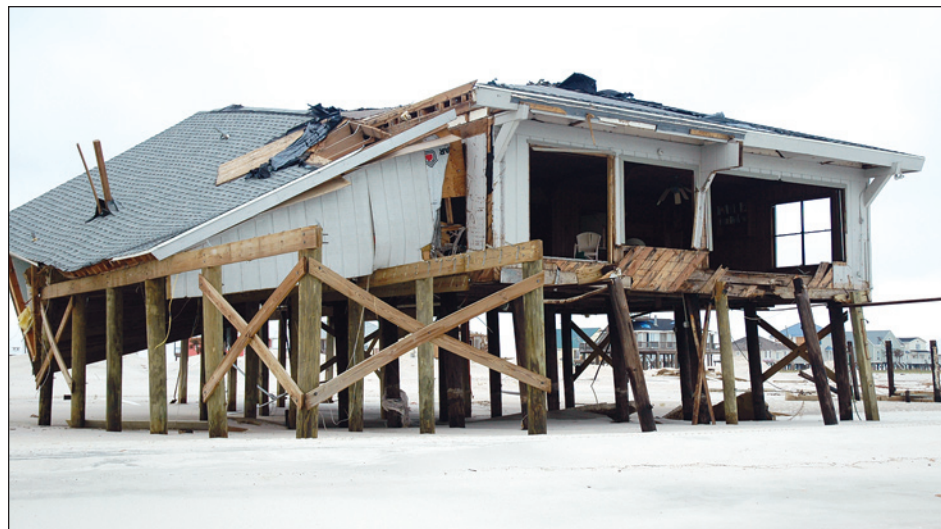
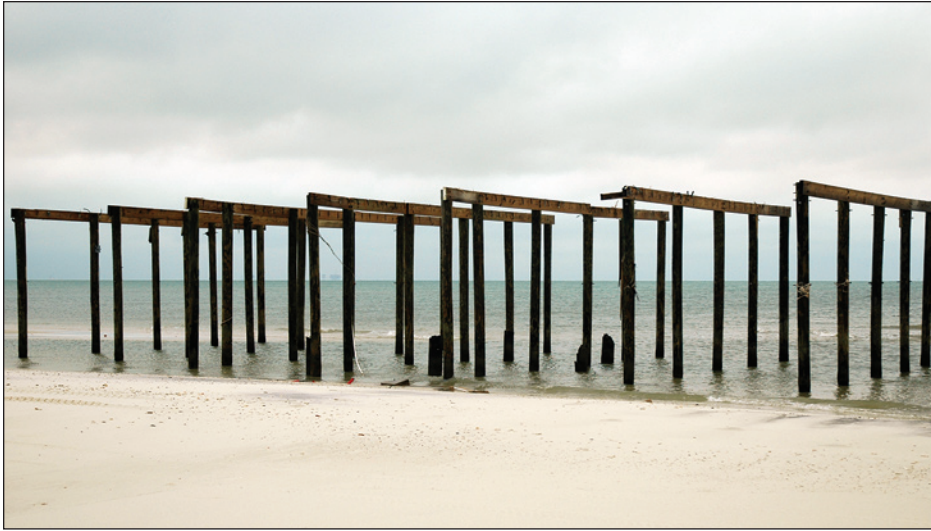
Figure 4-8.  
Total wave damage after  
wave heights exceeded  
the floor elevations  
(Dauphin Island, Alabama)

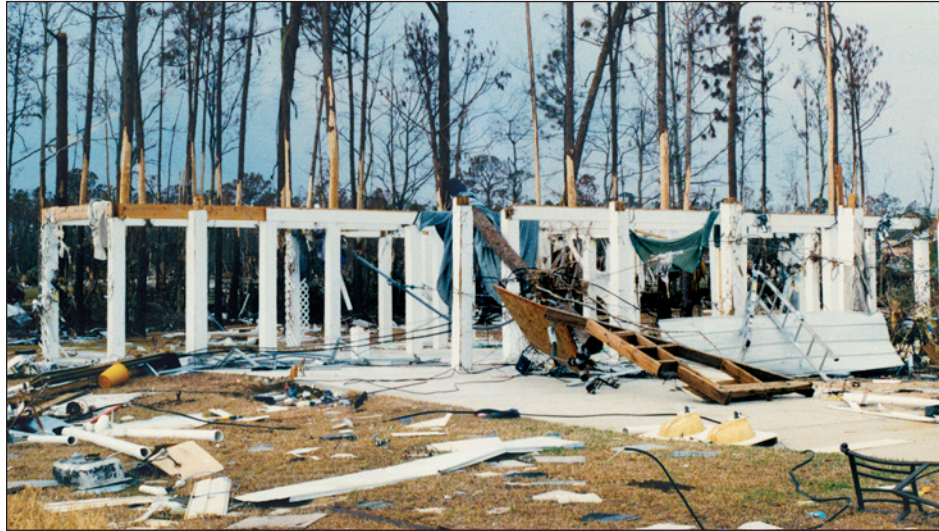
(see Figure 4-10) and on the north-facing bay shoreline in Bay St. Louis (see Figure 4-11). In most cases, the waves destroyed the floor beams, joists and above, but left the piles in place where erosion was not a significant factor.

**Figure 4-11.**  
Pile and connection failure  
(Bay St. Louis, Mississippi)

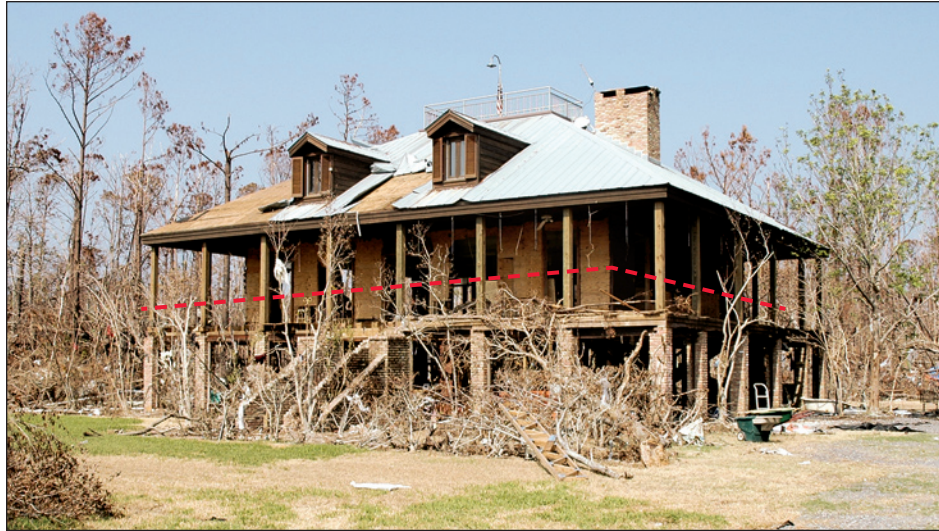
Figures 4-12 through Figure 4-14 show an example of a house with timber pole-type construction. Wave heights exceeded the elevated floor level by approximately 4 feet, lateral wave forces destroyed many of the exterior and interior walls, and wave uplift damaged the floor (Figure 4-14) and interior floors. However, the upper portion of the structure and the roof remained stable due to the nature of the foundation and structural frame.

**Figure 4-14.**  
Wave damage to floors and walls, but pole construction left a repairable, surviving building (Waveland, Mississippi)

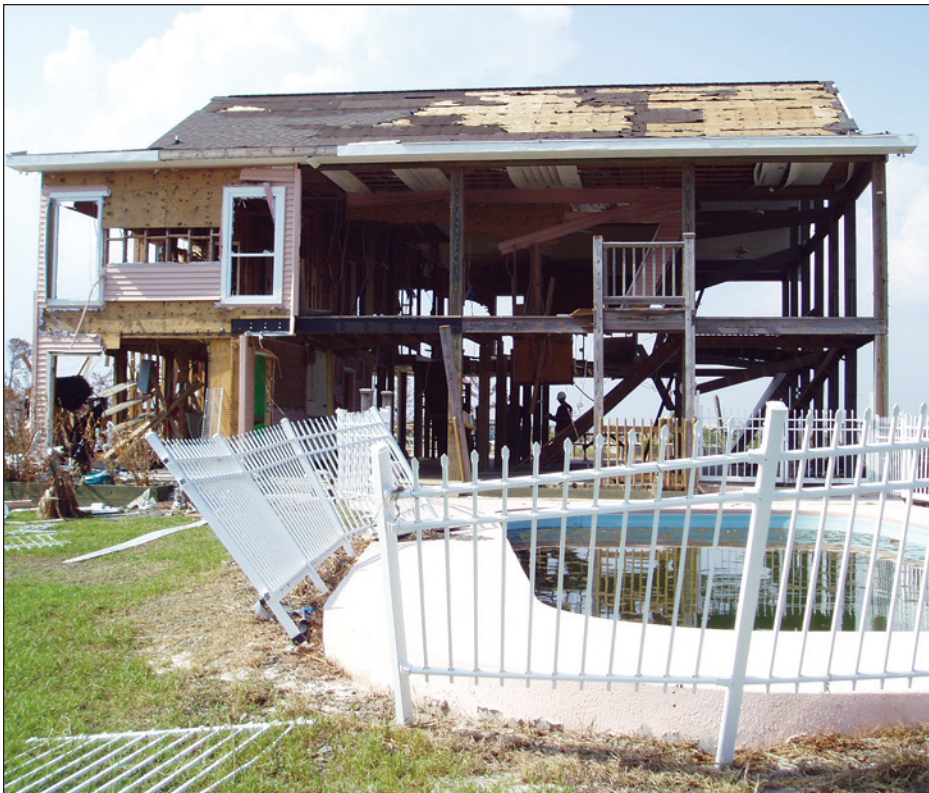
Figure 4-16.  
Wood-framed survivor  
exposed to storm surge  
and waves (Jourdan  
River shoreline of Bay St.  
Louis, Mississippi)

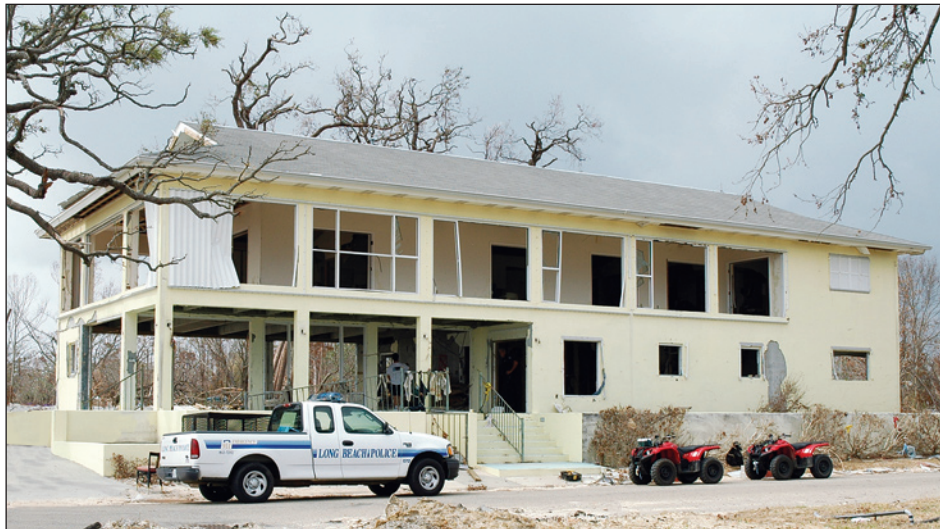
**Figure 4-19.**  
Another surviving house constructed with a reinforced concrete frame. The wave elevation was approximately 2 to 3 feet above the elevated floor (Long Beach, Mississippi).

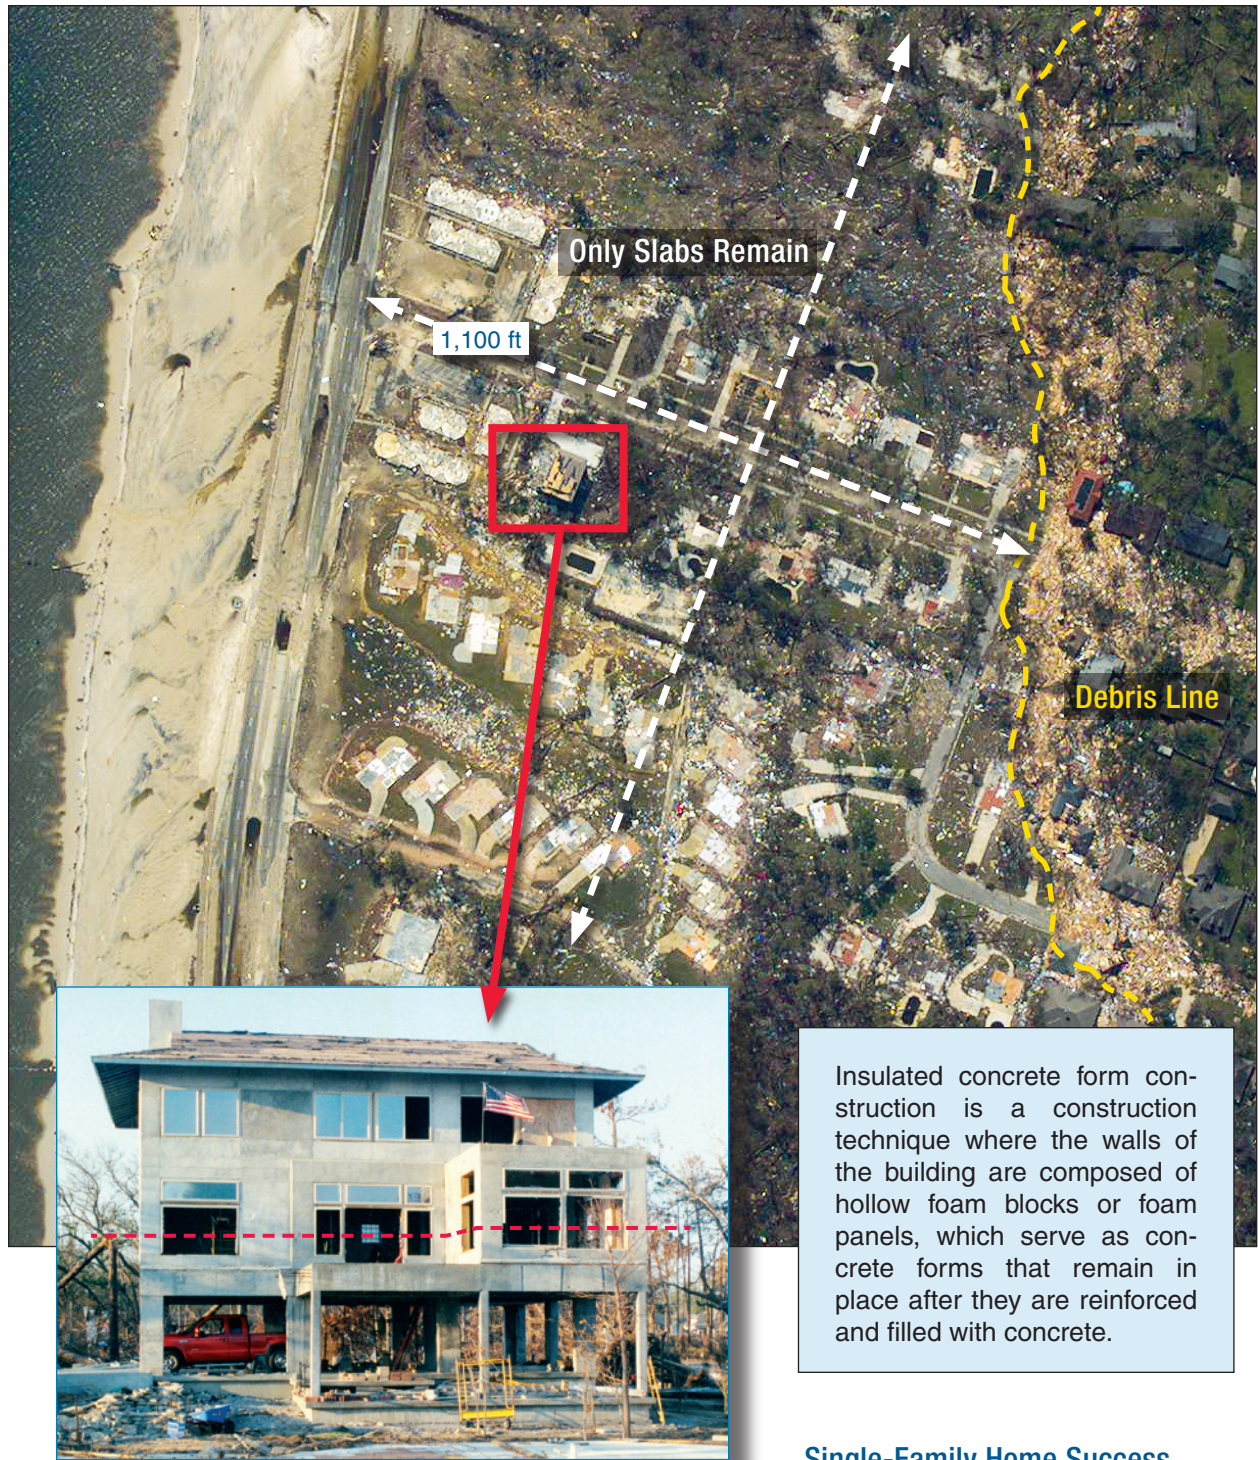
Figure 4-20.

Success amidst dozens of destroyed homes; the house was constructed with a reinforced concrete frame and insulated concrete form walls. Waves during Katrina washed through the elevated portion of the house (white dashed lines on aerial indicate total destruction of all houses except the one in the insert; red line on house indicates flood level) (Pass Christian, Mississippi).

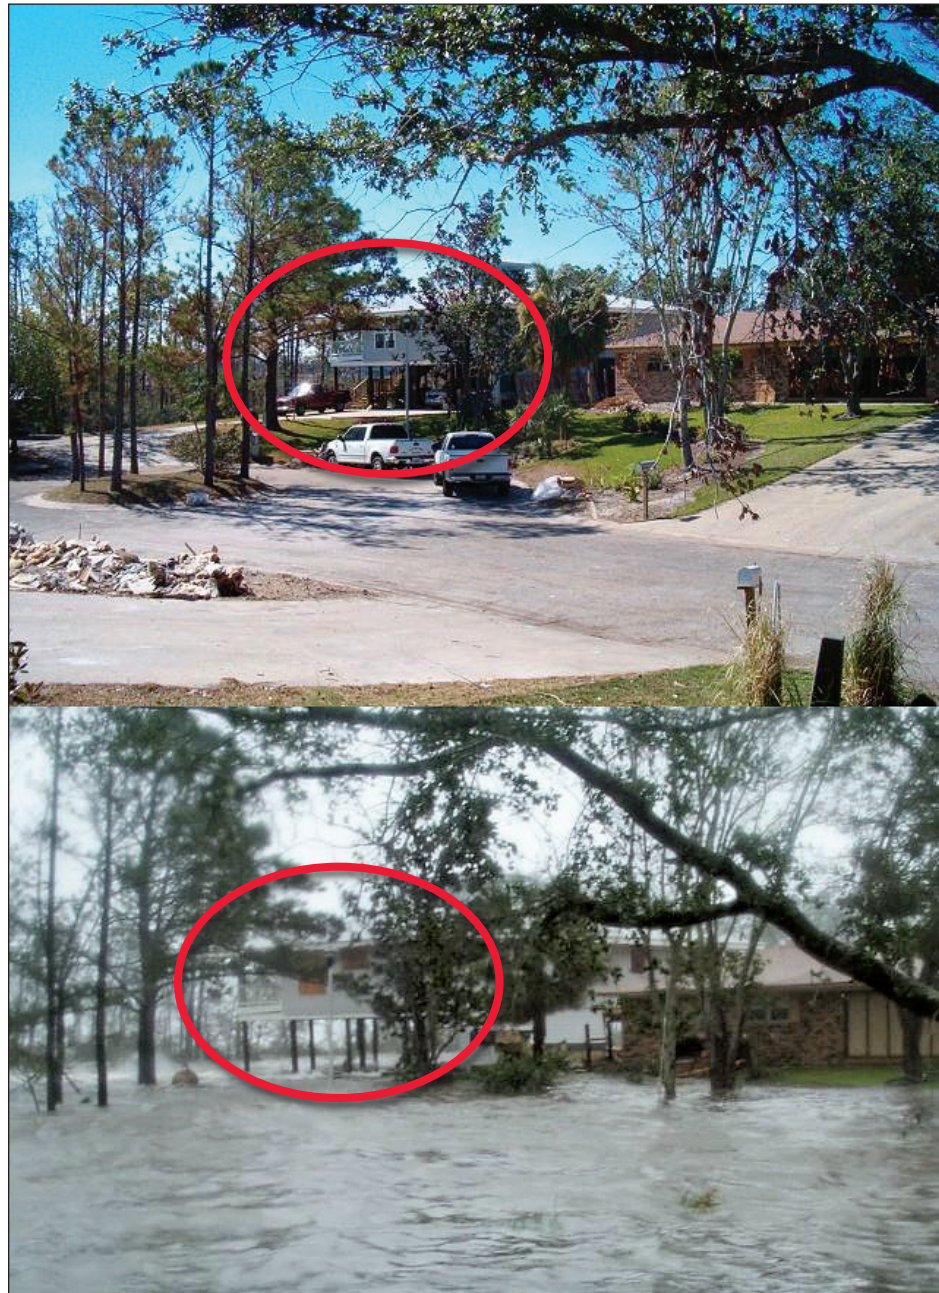
**Figure 4-21.**  
Successful pole construction home (background) near Old Fort Bayou. The top photo was taken approximately 3 weeks after Hurricane Katrina. The lower photo was taken during Katrina (the water level had dropped approximately 6 feet from its peak when the photo was taken) (Ocean Springs, Mississippi).

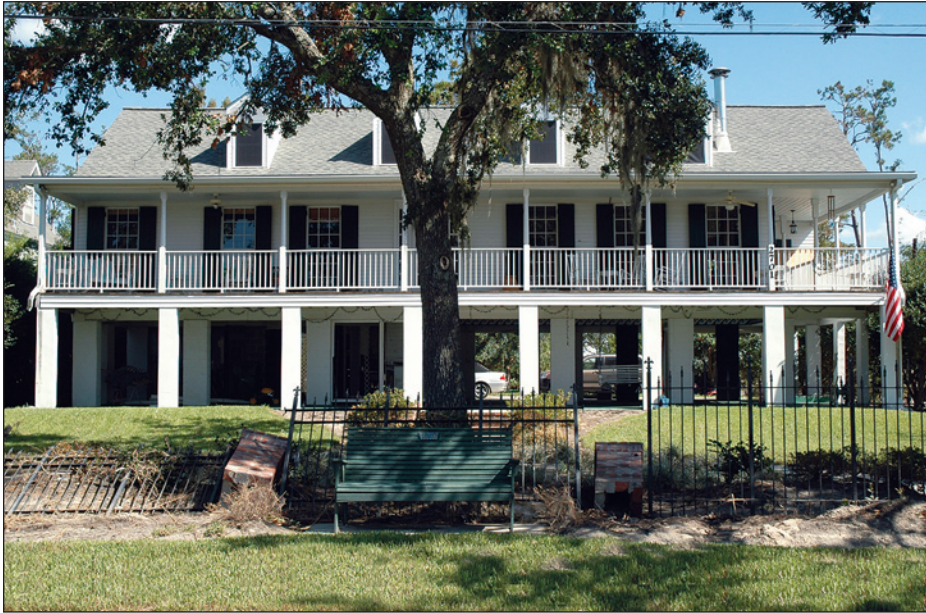
When properly designed and constructed, piers were effective foundations as long as storm surge and waves remained below the floor beam and floor system components, and erosion and scour did not undermine the foundations. In Mandeville, Louisiana (see Figures 4-22 and 4-23), on the north shoreline of Lake Pontchartrain, storm surge in the lake was close to the predicted BFEs. Many buildings along the lakefront experienced storm surge and waves ranging from 2 to 6 feet above existing grade; however, buildings were adequately set back from the shoreline such that erosion was not a threat around most building locations.

Figure 4-22.  
Pier-supported house  
with minimal flood  
damage (Mandeville,  
Louisiana)

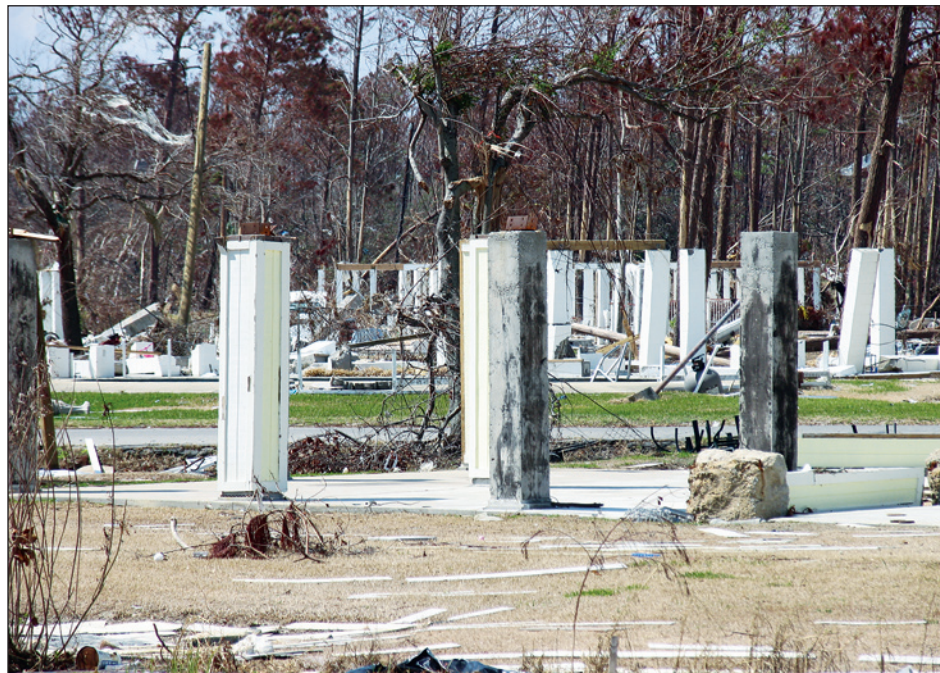
As with pile foundations, when Katrina's storm surge and even small waves exceeded the pier foundation height and impacted the elevated building, damage was severe. Total building loss is shown in Figures 4-24 and 4-25. Such losses of houses elevated on piers 9 to 12 feet above grade were widespread across coastal Louisiana and Mississippi near the Gulf and around larger bays.

**Figure 4-24.**  
Typical building failures  
when surge and waves  
exceeded pier foundation  
height (Long Beach,  
Mississippi)

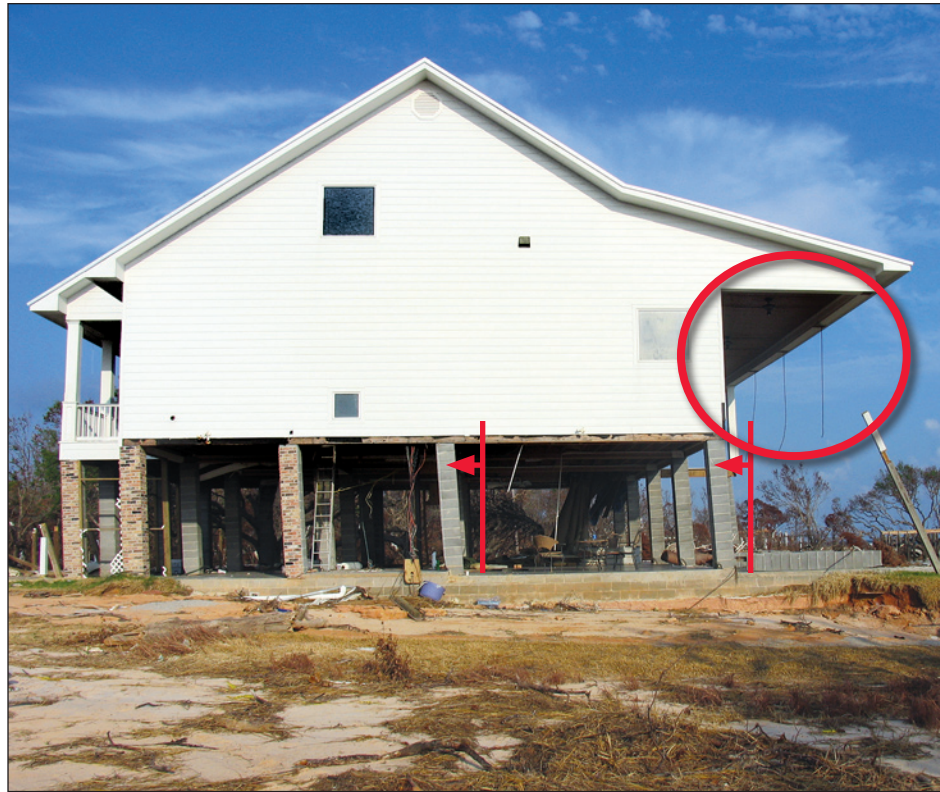
Figure 4-27.

Tops of piers have been pushed landward, probably due to wave effects on the foundation and lateral wind loads on the building. Note reinforcing bars hanging from the porch roof overhang (circle). These bars were placed through wood columns and attached to the foundation, apparently as a way of providing wind uplift resistance for the wide overhang (Belle Fontaine Point, Jackson County, Mississippi).

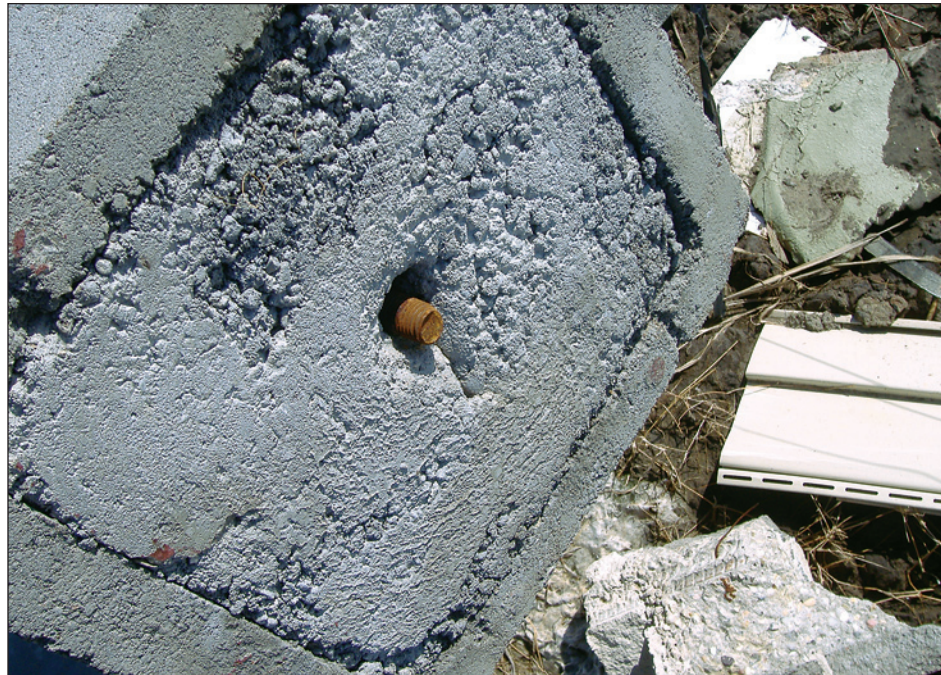
**Figure 4-30.**  
Failure from a poorly  
detailed pier to beam  
connection (Long Beach,  
Mississippi)

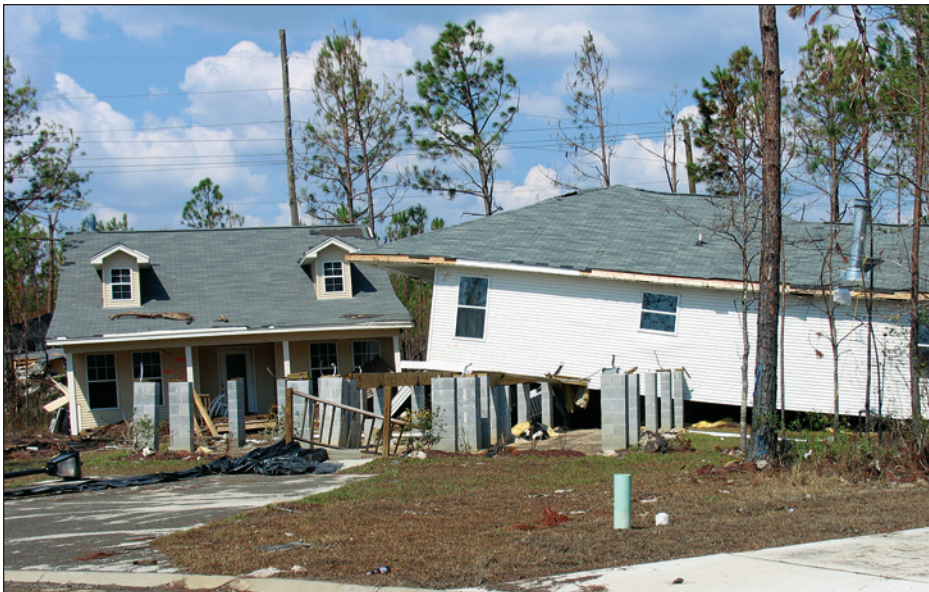
Figure 4-31.

The MAT also observed instances where lateral flood and wind forces acting on a building caused failure in the connections between the piers and the building before the foundation itself failed (see Figure 4-31). The result was foundations standing after the storm with no buildings atop the foundations.

Failure of pier-to-beam connections due to wave and flood forces acting on the elevated building (Long Beach, Mississippi)

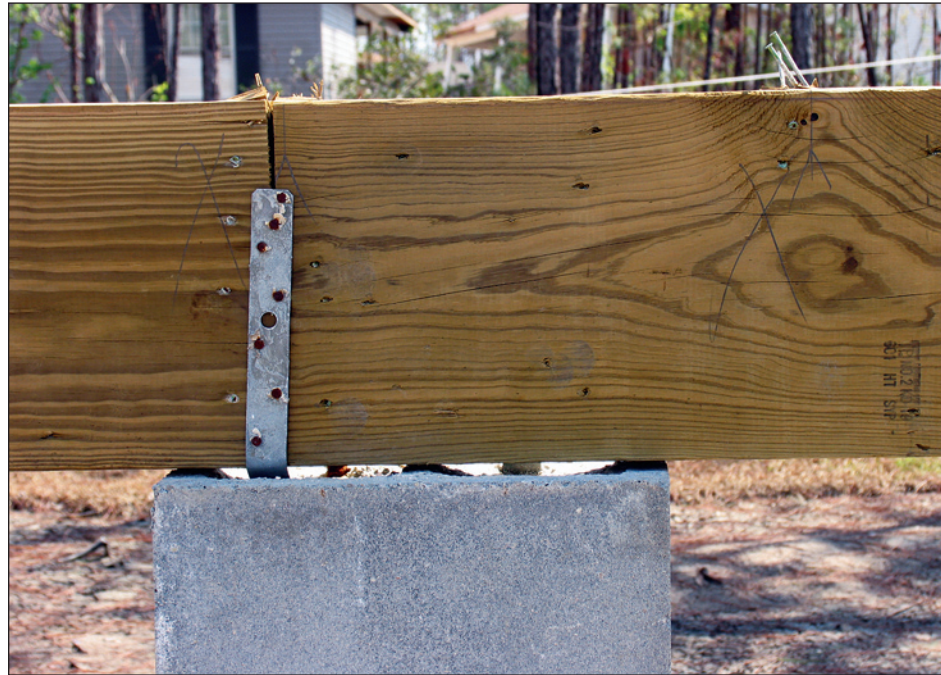
Figure 4-33.  
Poor pier-to-beam connection. Although this particular connection did not fail (because the wall and floor-to-beam connections failed first), this connection is poor. Note use of light gauge metal straps and nailing of strap at a joint in the beam (Pass Christian, Mississippi).

Figure 4-34.  
A preferred pier-to-beam connection capable of resisting flotation and wind (uplift and lateral) loads can be made using heavy beam seats.

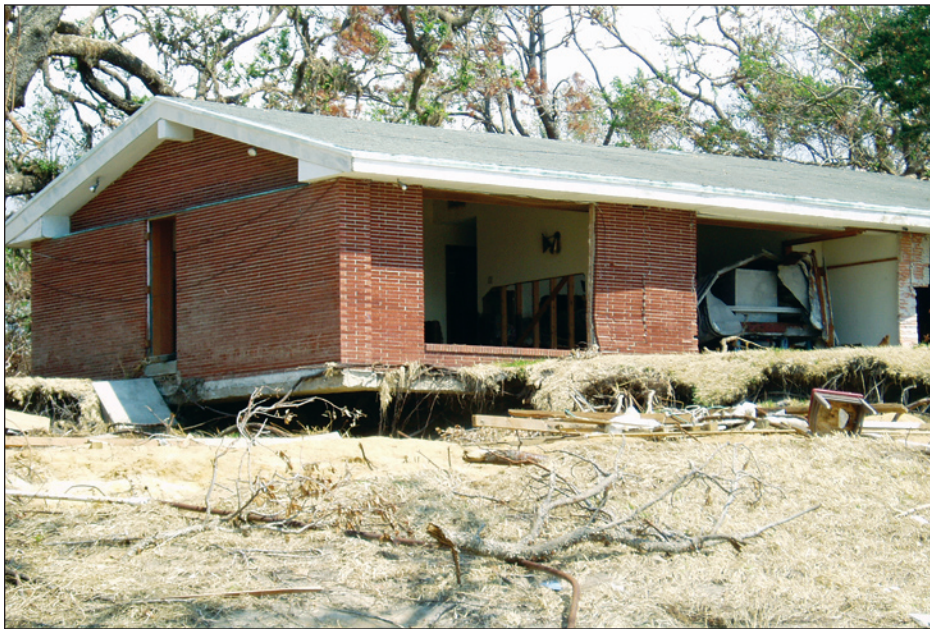
Figure 4-35.  
Slab-on-grade  
undermining (Ocean  
Springs, Mississippi)

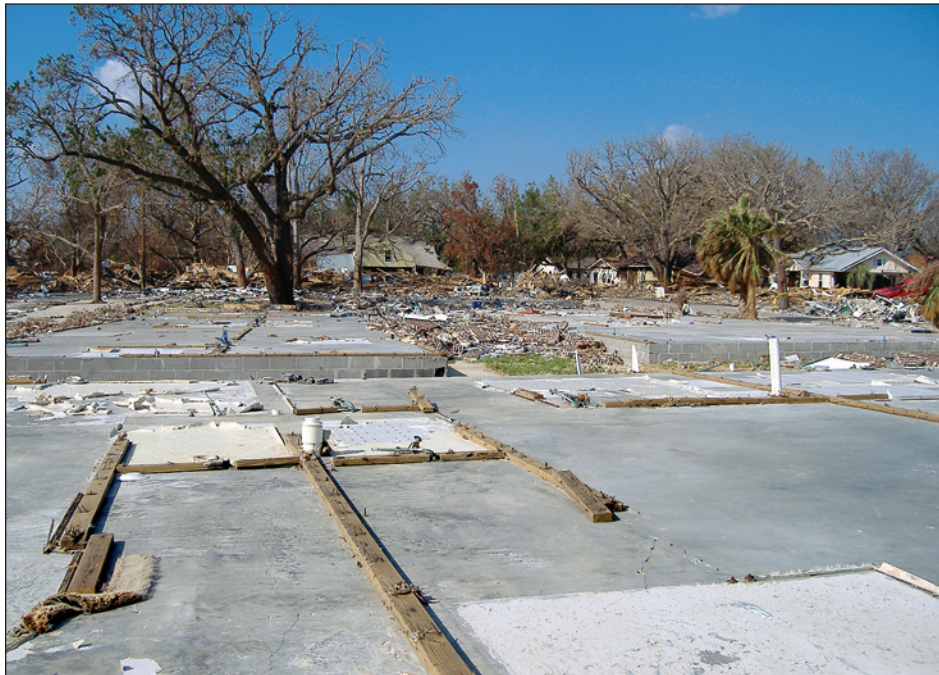
**Figure 4-37.**  
Waves, surge, and floating debris destroyed many single-family homes on slab foundations. Note debris from houses washed landward into other buildings (Biloxi, Mississippi).

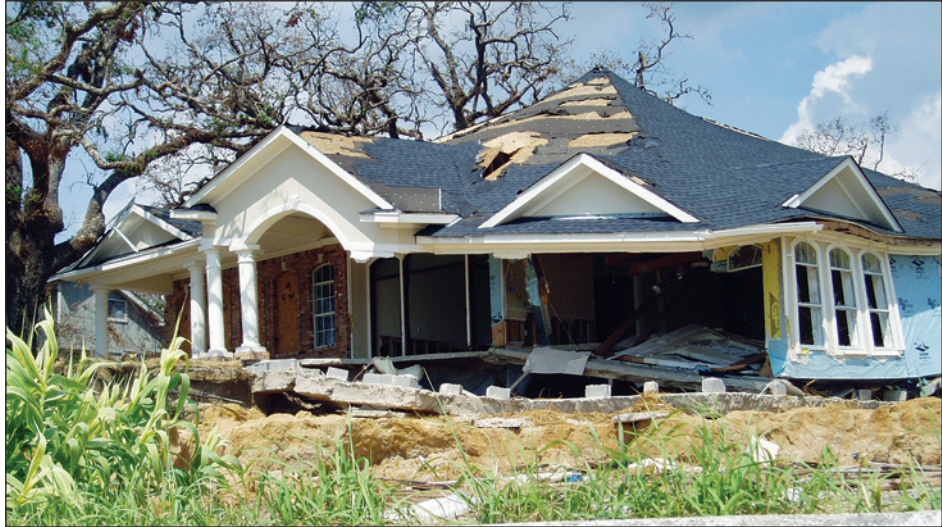
undermining due to erosion or localized scour. If undermined, the contained fill can be lost, removing support for the slab floor, as shown in Figure 4-39. Similar to buildings with slab-on-grade foundations, buildings with stem wall foundations experienced severe damage when flood levels and wave heights far exceeded the top of the slab (see Figure 4-40).

**Figure 4-39.**  
Shallow foundation failure due to localized scour and damage to walls by surge and wave impacts (Ocean Springs, Mississippi)

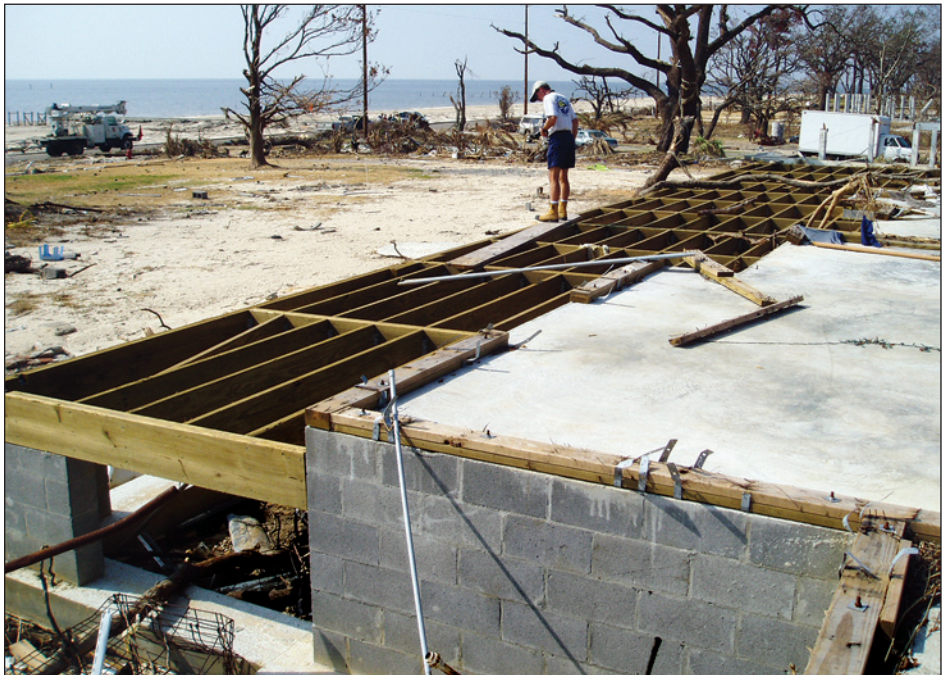
**Figure 4-40.**  
Stem wall foundation survived intact, but waves and surge above the floor destroyed the house, sweeping it off the foundation (Waveland, Mississippi).

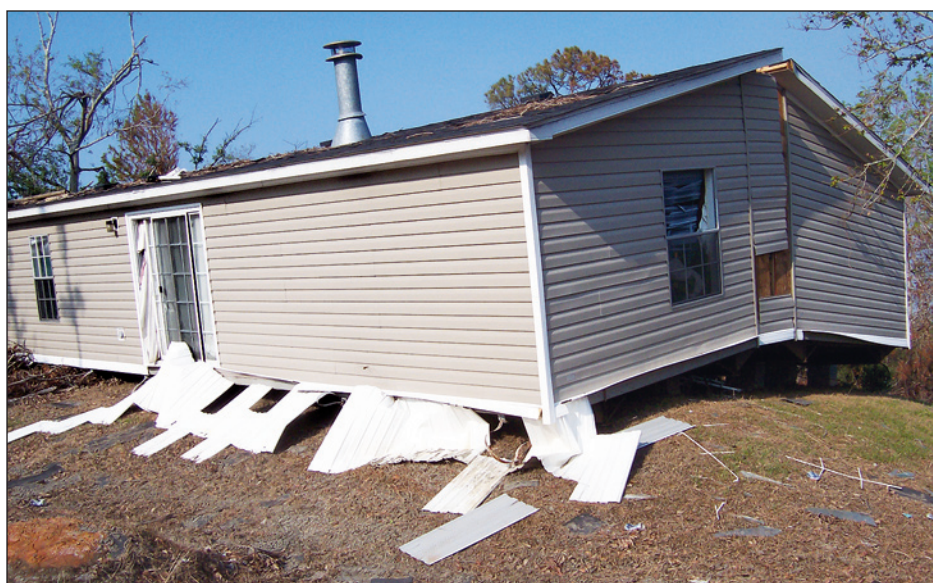
**Figure 4-41.**  
Collapse of manufactured home due to loss of anchorage and pier settlement (indicative of soil saturation under flooded conditions) (Pass Christian, Mississippi).

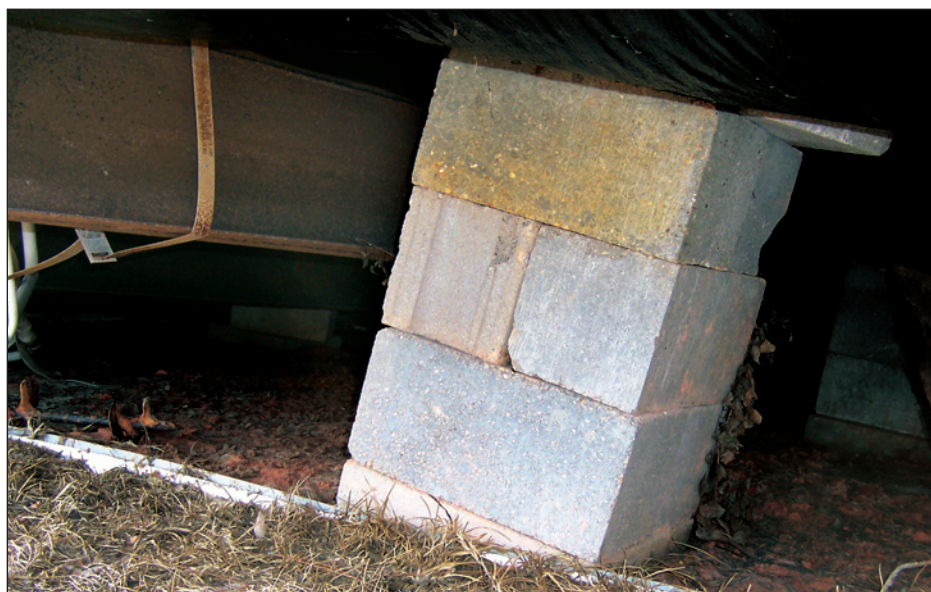
**Figure 4-42.**  
Dry-stacked pier under home rotated 20 degrees from vertical (Pass Christian, Mississippi).

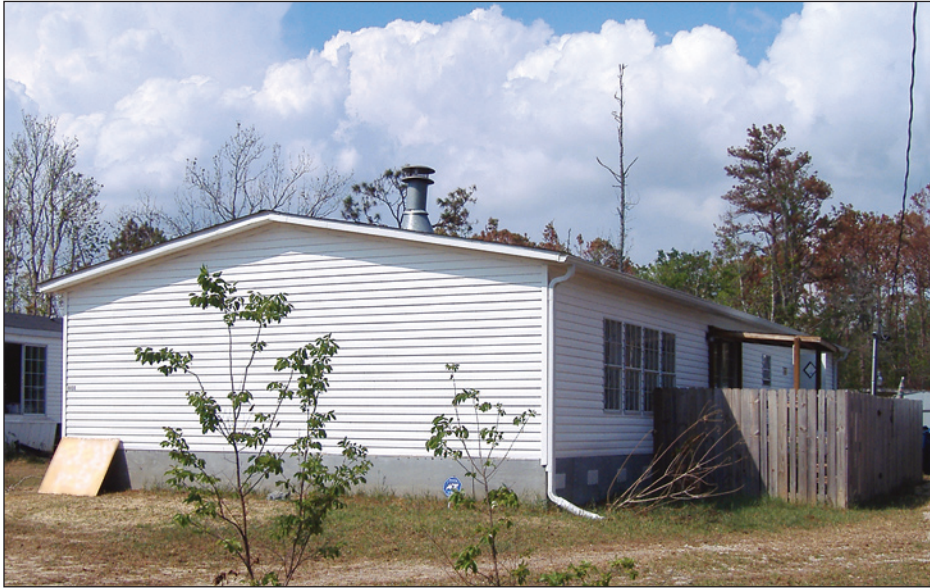
**Figure 4-43.** Manufactured home placed on and secured to poured concrete strip footing had floodwaters 6 feet above its floor, but was not moved from its foundation. Although this indicates good foundation performance, the cost of repairing may exceed the value of the residence because of the significant inundation damage (Ocean Springs, Mississippi).

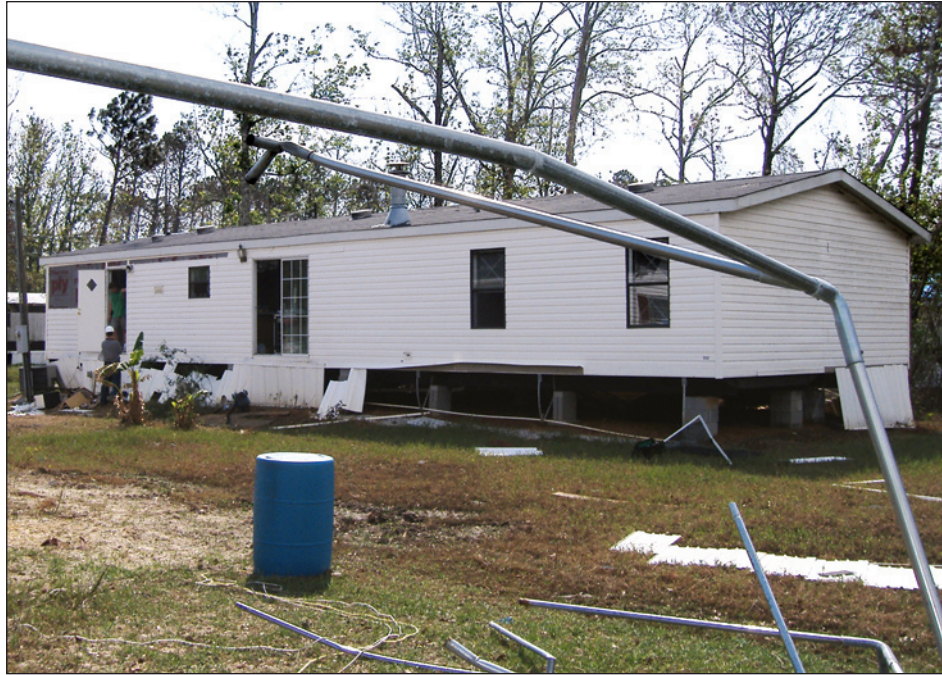
**Figure 4-46.**

Foundation of manufactured home in Figure 4-45. Although the home did not collapse, the ground anchors were partially pulled out of the ground (probably by flotation and lateral flood forces on the home under saturated soil conditions) and it shifted laterally on its piers (Ocean Springs, Mississippi).

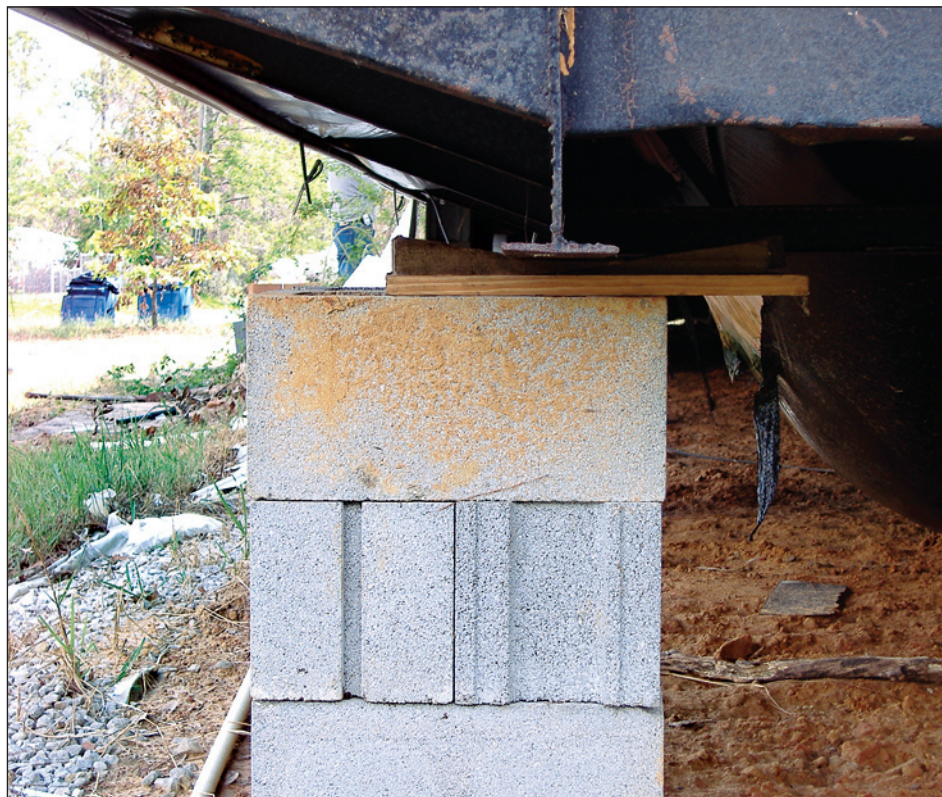
Figure 4-48.  
Foundation of home  
shown in Figure 4-47.  
The flood level rose  
above the floor, the  
ground anchors were  
apparently pulled up from  
the saturated soil, and  
the piers were displaced  
(St. Bernard Parish,  
Louisiana).

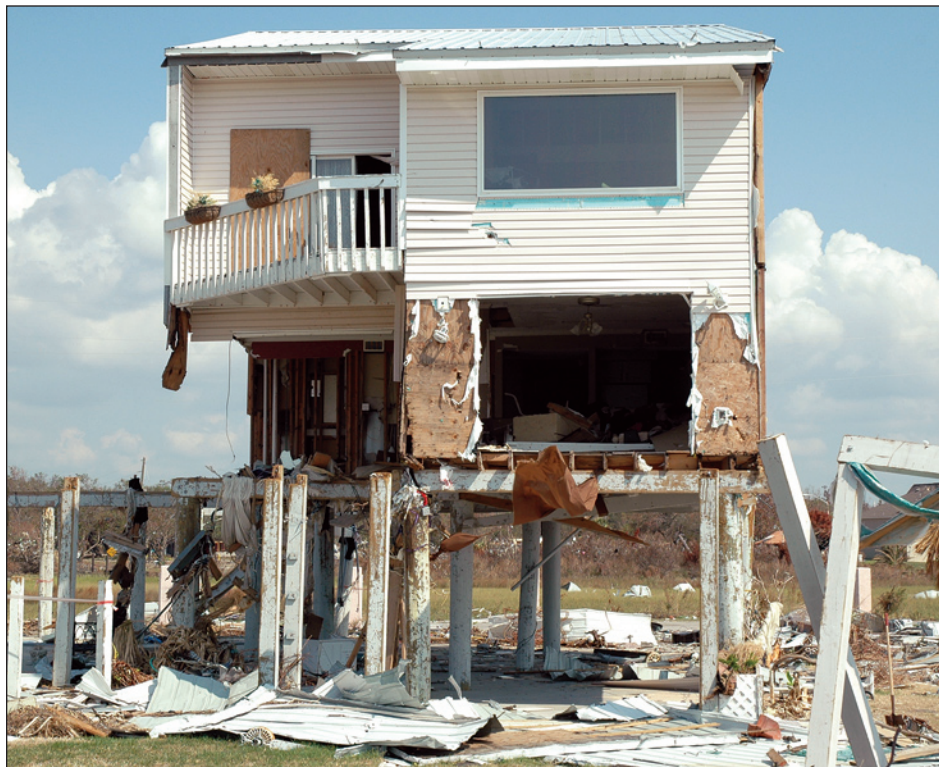
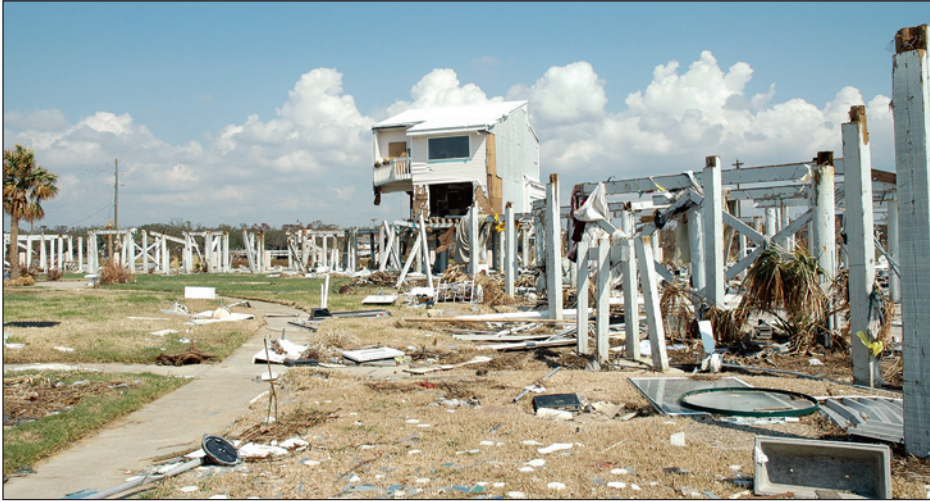
Low-rise, multi-family residential buildings were constructed on the same types of foundations used for single-family houses. Performance of these buildings during flooding was similar to that of single-family houses. With stillwater levels, storm surge, and wave elevations well above the BFEs, flood damage to affected multi-family structures was widespread and severe. The pile-supported Pascagoula condominium unit in Figures 4-49 and 4-50 lost bearing walls due to lateral wave forces, and elevated floors due to wave uplift. The unit was the only remaining one out of 20 (Figure 4-50).

**Figure 4-49.**  
Severely damaged  
condominium unit was  
the only one remaining  
of 20 units (Pascagoula,  
Mississippi)

Figure 4-50.  
Another view of the  
severely damaged  
condominium unit  
shown in Figure 4-49  
(Pascagoula, Mississippi)

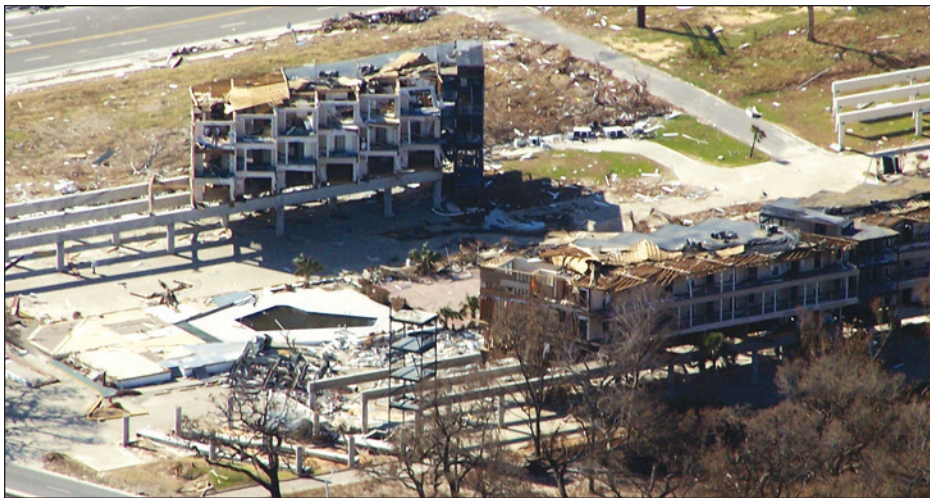
The condominium in Figures 4-51 and 4-52 was supported on heavy reinforced concrete columns and beams, but progressively failed from lateral and uplift wave loads on the lower unit load-bearing walls and floors. Note that wind impacts to the building, apparent at the roof and upper stories, may have also contributed to building damage.

Figure 4-51.  
Condominium on heavy  
concrete foundation  
severely damaged  
when wave elevations  
exceeded lower floor  
elevations (Gulfport,  
Mississippi)
